Evaluation of the Causes of Housing Decay in Ibadan Core Settlements

Table I: Observation Assessment of Housing Condition in the Study Area, Ibadan

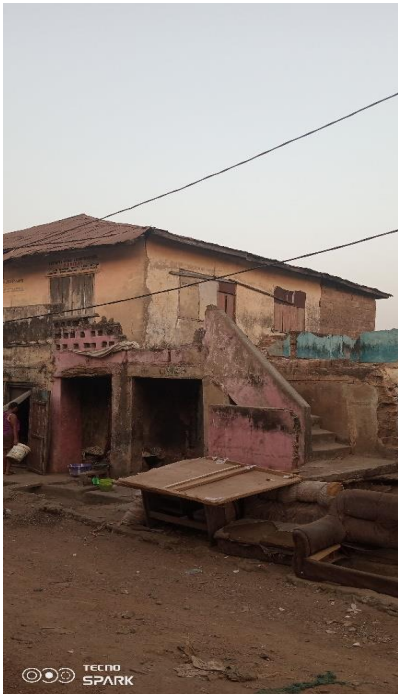
Fig 1. Hanging Wall

Fig. 1, 2 and 3 shows level of dilapidation with virtual hanging walls, overall rustic roof conditions as well as exposed foundation condition of the buildings in the area. While Fig 4, 5 and 6 showed Exposed Wall, Wall Cracks, Peep Off Paints, which demonstrated the state of dereliction and decay of the study area. Consequently, Fig 7, 8, 9 & 10 shows evidence of Up Lifted Overlaps, twisted & Loose door / Windows which are signs of age, poor maintenance and longtime abandonment of the buildings in the area.

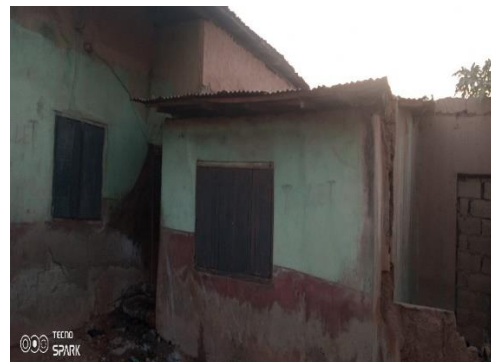
Fig. 11. Peeled paint & wall cracks

Fig. 11, 12 and 13 shows level of dilapidation with virtual hanging walls, overall rustic roof conditions as well as exposed foundation condition of the buildings in the area similar to the physical conditions of building at Bode. While Fig 14, showed Peep Off Paints, blown roof section, hanging facial, open ridges, loose door and window which demonstrated the state of dereliction and decay of the study area.

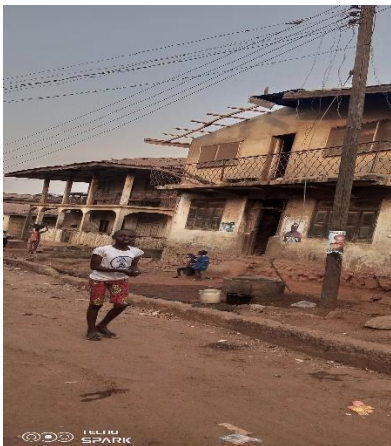
Fig. 15. Peeled Paint, Falling Roofing & Hanging Facial

Fig. 15, 16 and 17 shows level of dilapidation with evidence of peeled paint, falling roofing & hanging facial, falling ceiling covering conditions as well as exposed foundation condition of the buildings in the area similar to the physical conditions of buildings at Popo. While Fig 18, 19 and 20, Uplifted overlap, Exposed Wall and Rustic Roof, hanging facial, open ridges, loose door and window which demonstrated the state of dereliction and decay of the study area. Furthermore, Fig 21 and 22 showed Wall cracks and damp and Exposed foundation with poor state of living condition of the resident of the studied area.
